# EFU GENERAL INSURANCE

## SPECIFIC RISKS AND LOSS EXAMPLES FOR POWER PLANTS

Khurram Ali Khan

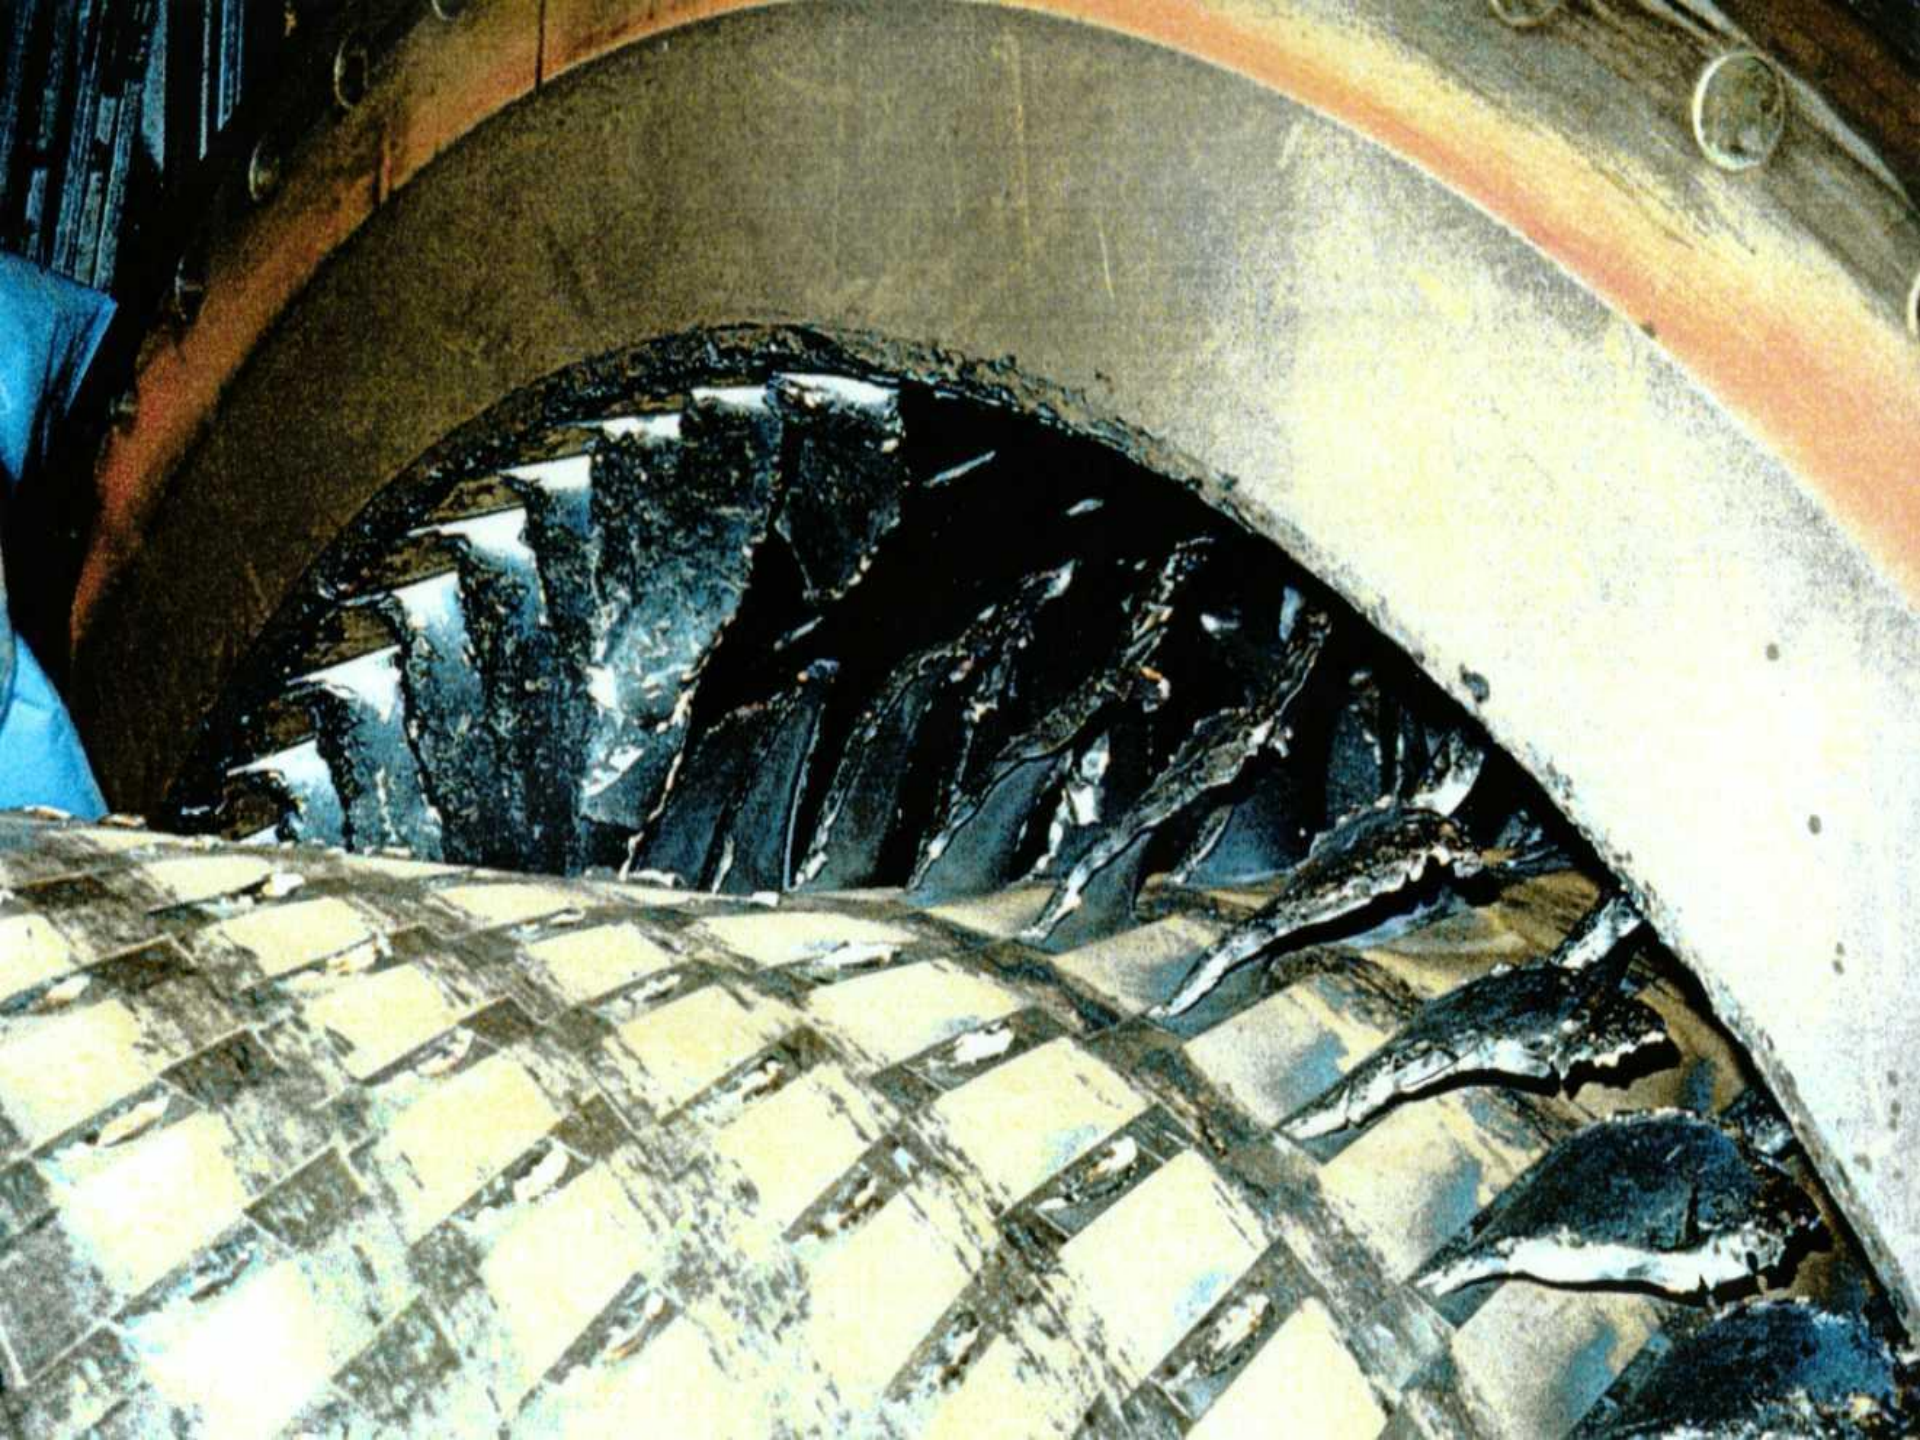
# A loss in a gas turbine

- **CCPP with a gas turbine of 240 MW**
- **Total loss to compressor and within combustion chamber**
- **Cause: rupture of 2nd row compressor blade**
- **Material damage US\$ 33 millions**
- **Plant outage for 8 months**

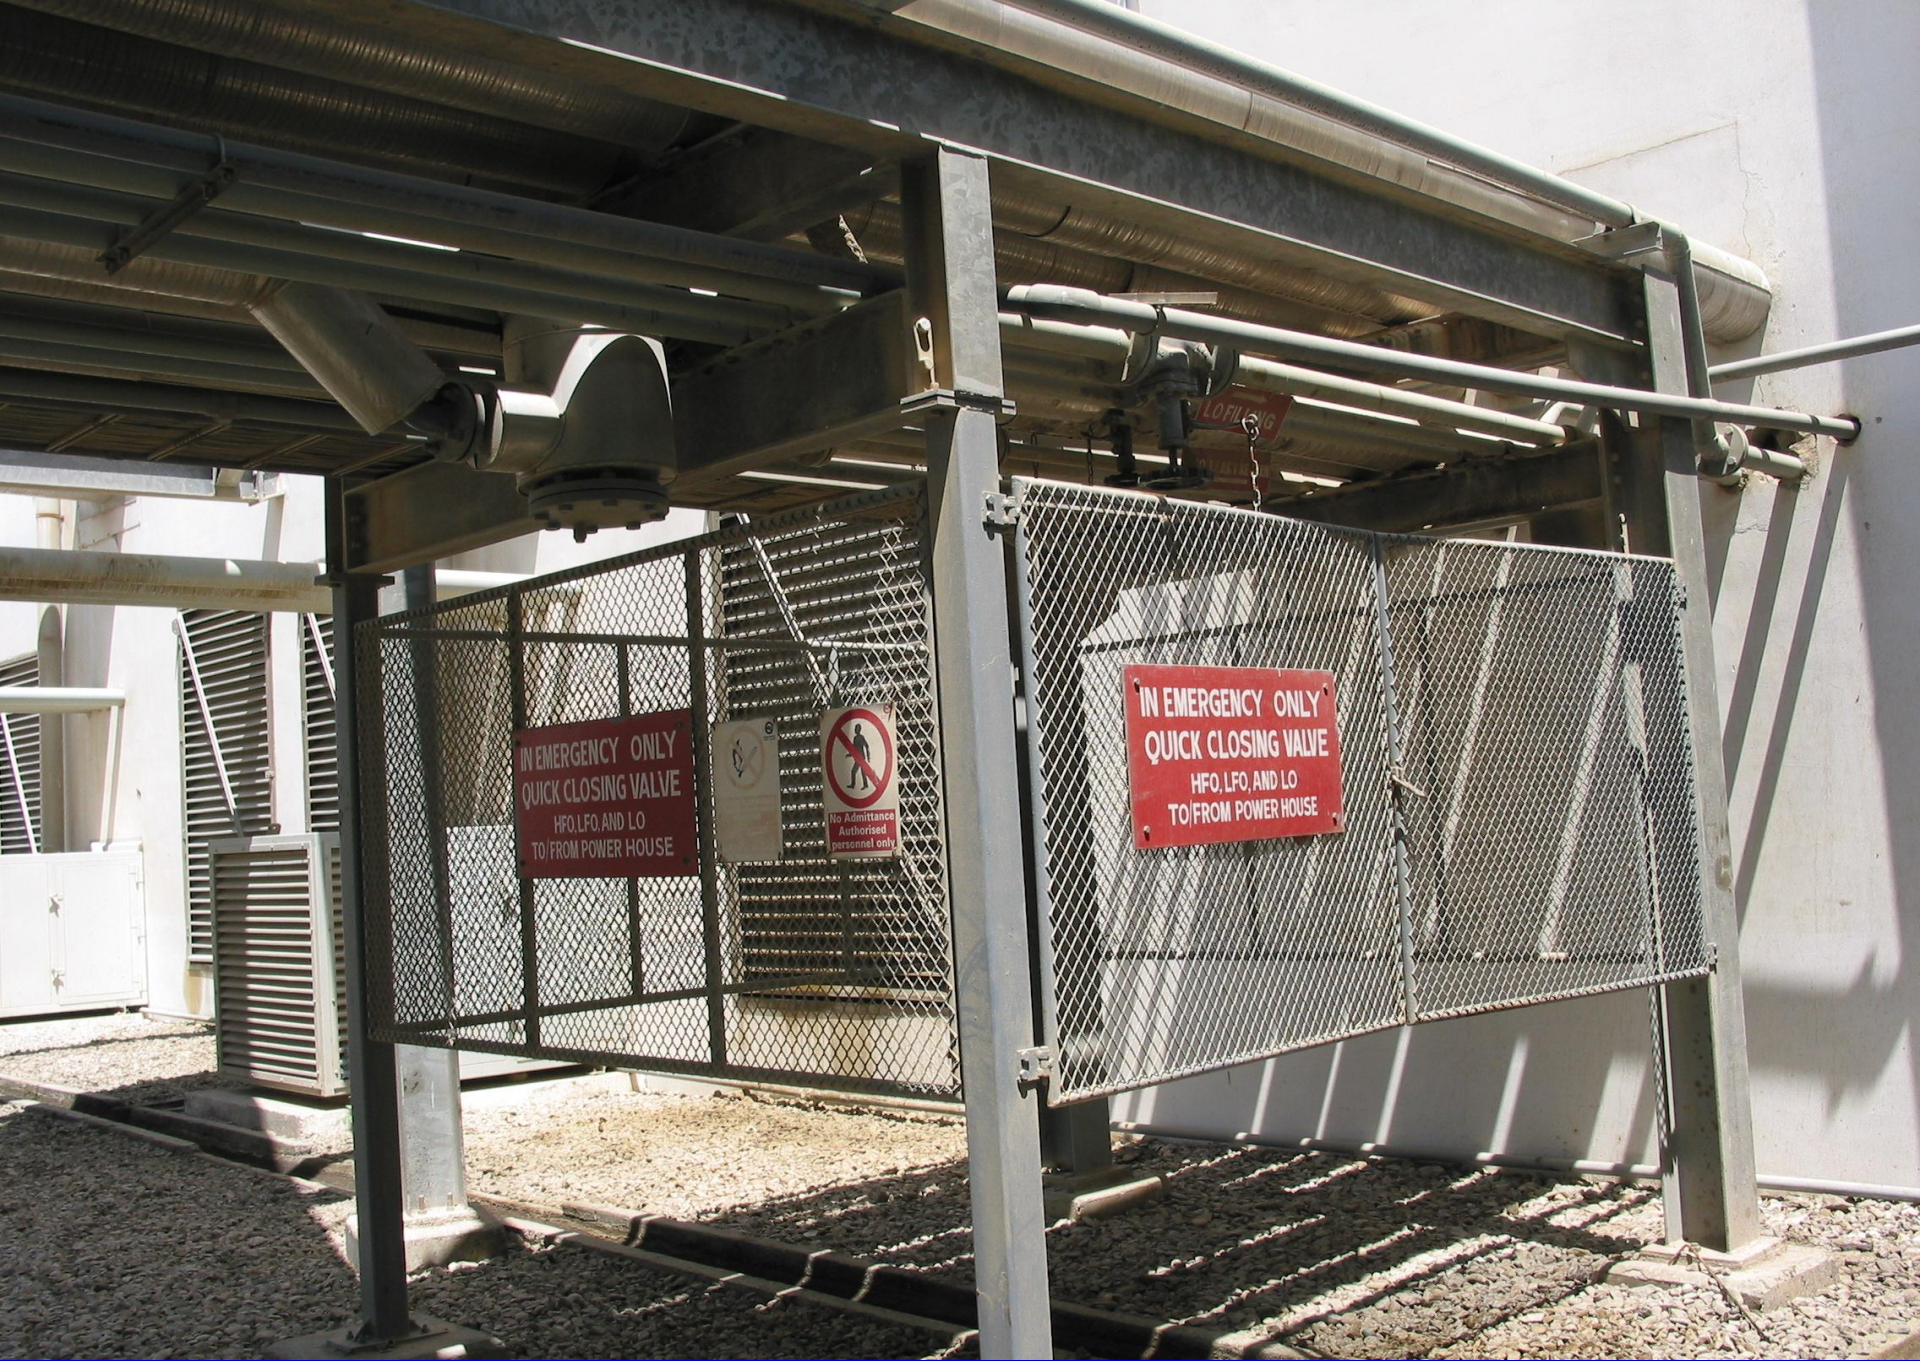
Fuel Oil Shut Off Valve

We recommended that the manual fuel shut off valve should be more easily accessible for rapid action. A chain had provided quick action earlier but this had been removed due to inadvertent operation in the past

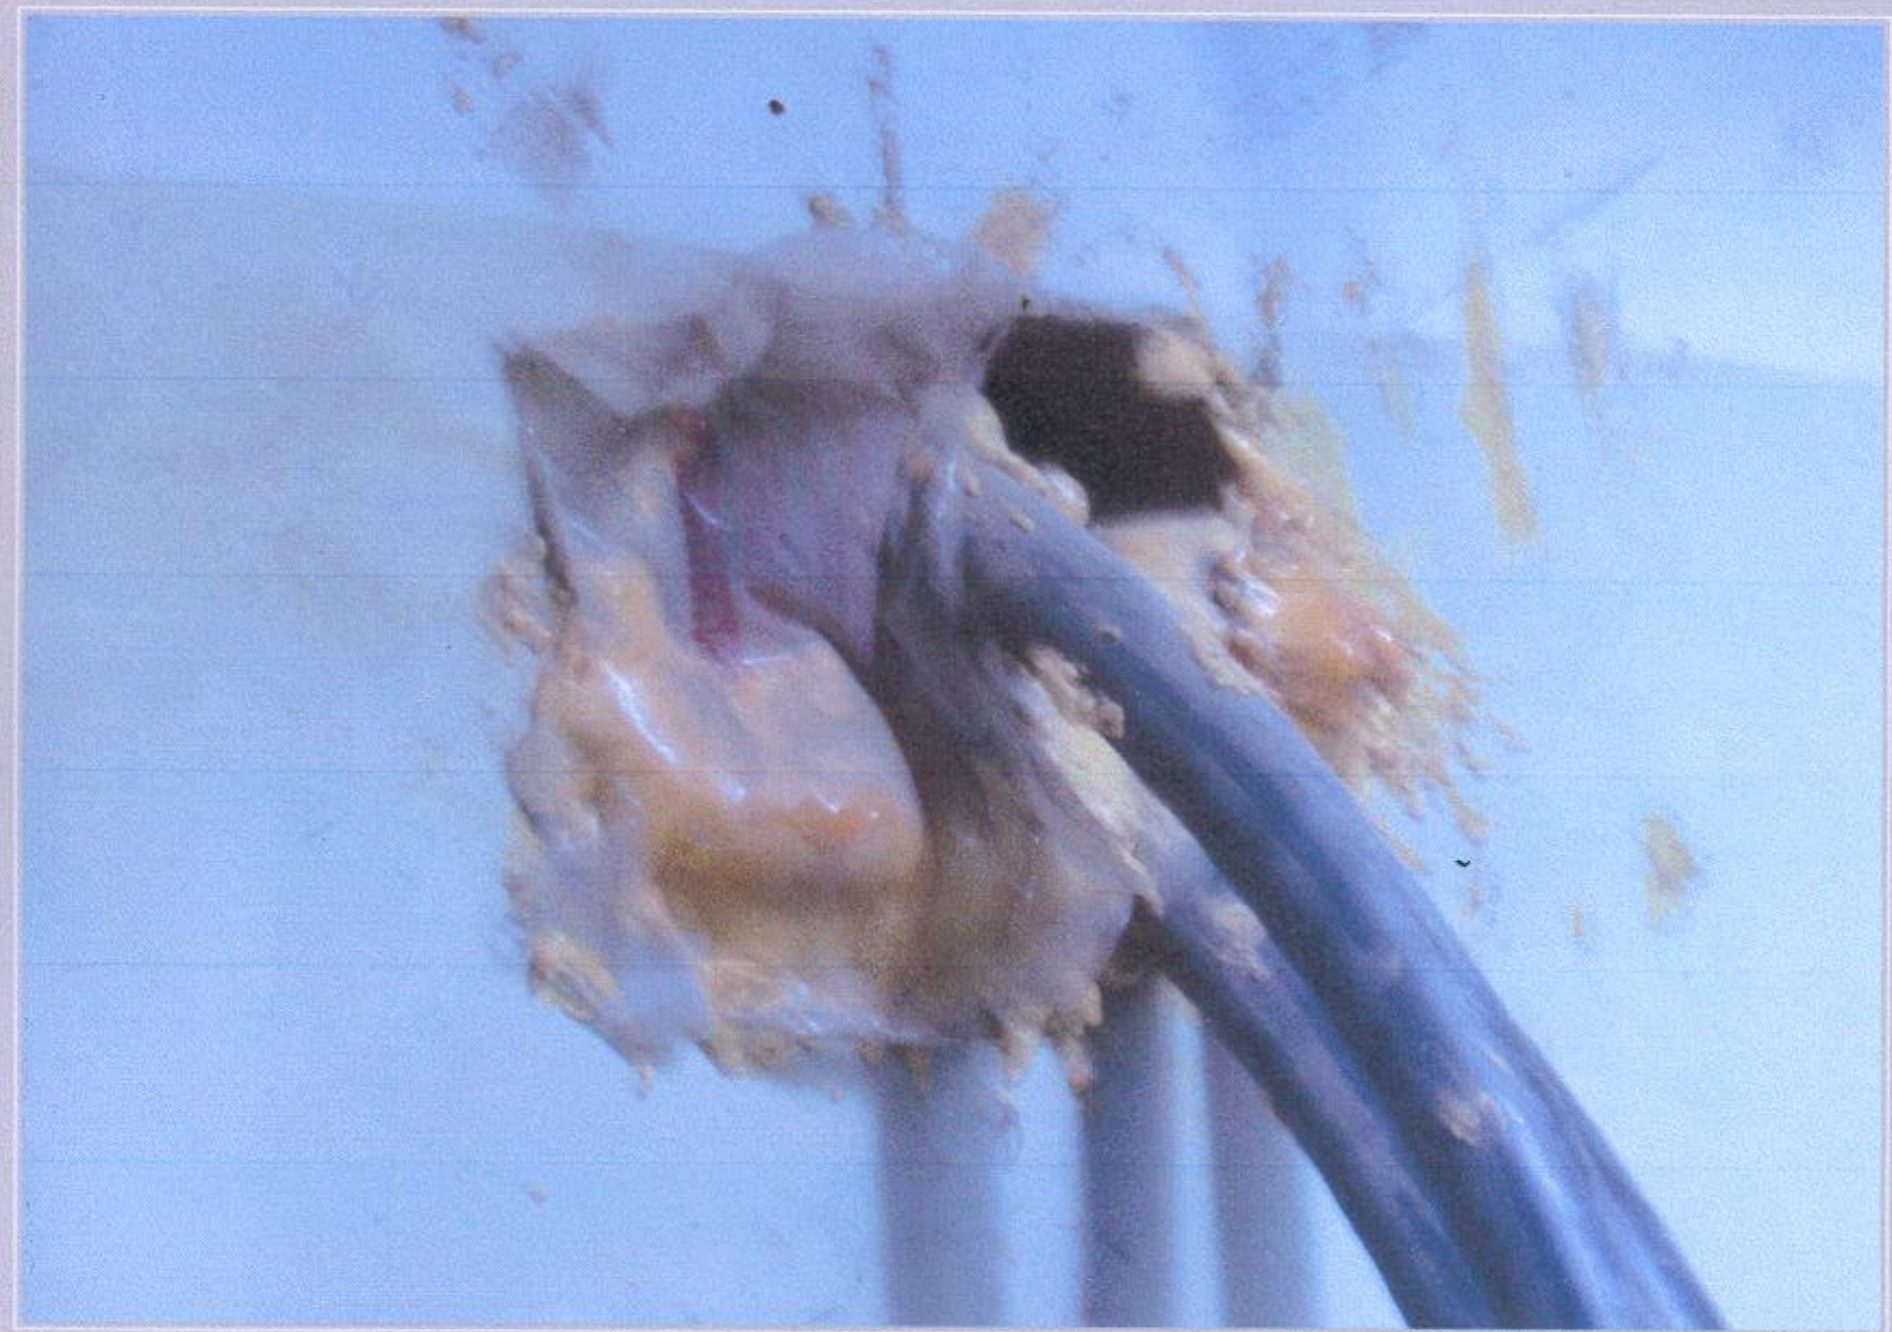
**Partial Sealing of Cable Run Penetrations of Basement Walls<sup>11</sup>**

We explained to managers and engineers during our visit the vulnerability of the underground cable spread areas and tunnels to low order of probability catastrophic fire incident. We recommended that fire barriers were required between the engine house, the cable basement and cable tunnels to limit the spread of fire incident along cables. Management appreciated the problem following our discussions and agreed to carry out a review and initiate action at an early date.

The objective should be to barrier and seal off large open penetrations from fire and smoke passage to limit the spread of fire incident wherever it initiates. Smaller penetrations such as cable should be sealed with an approved foam sealer. Underwriter Laboratory (UL) and Factor Mutual (FM) approved barrier material, paint and sealers set the standards to apply.

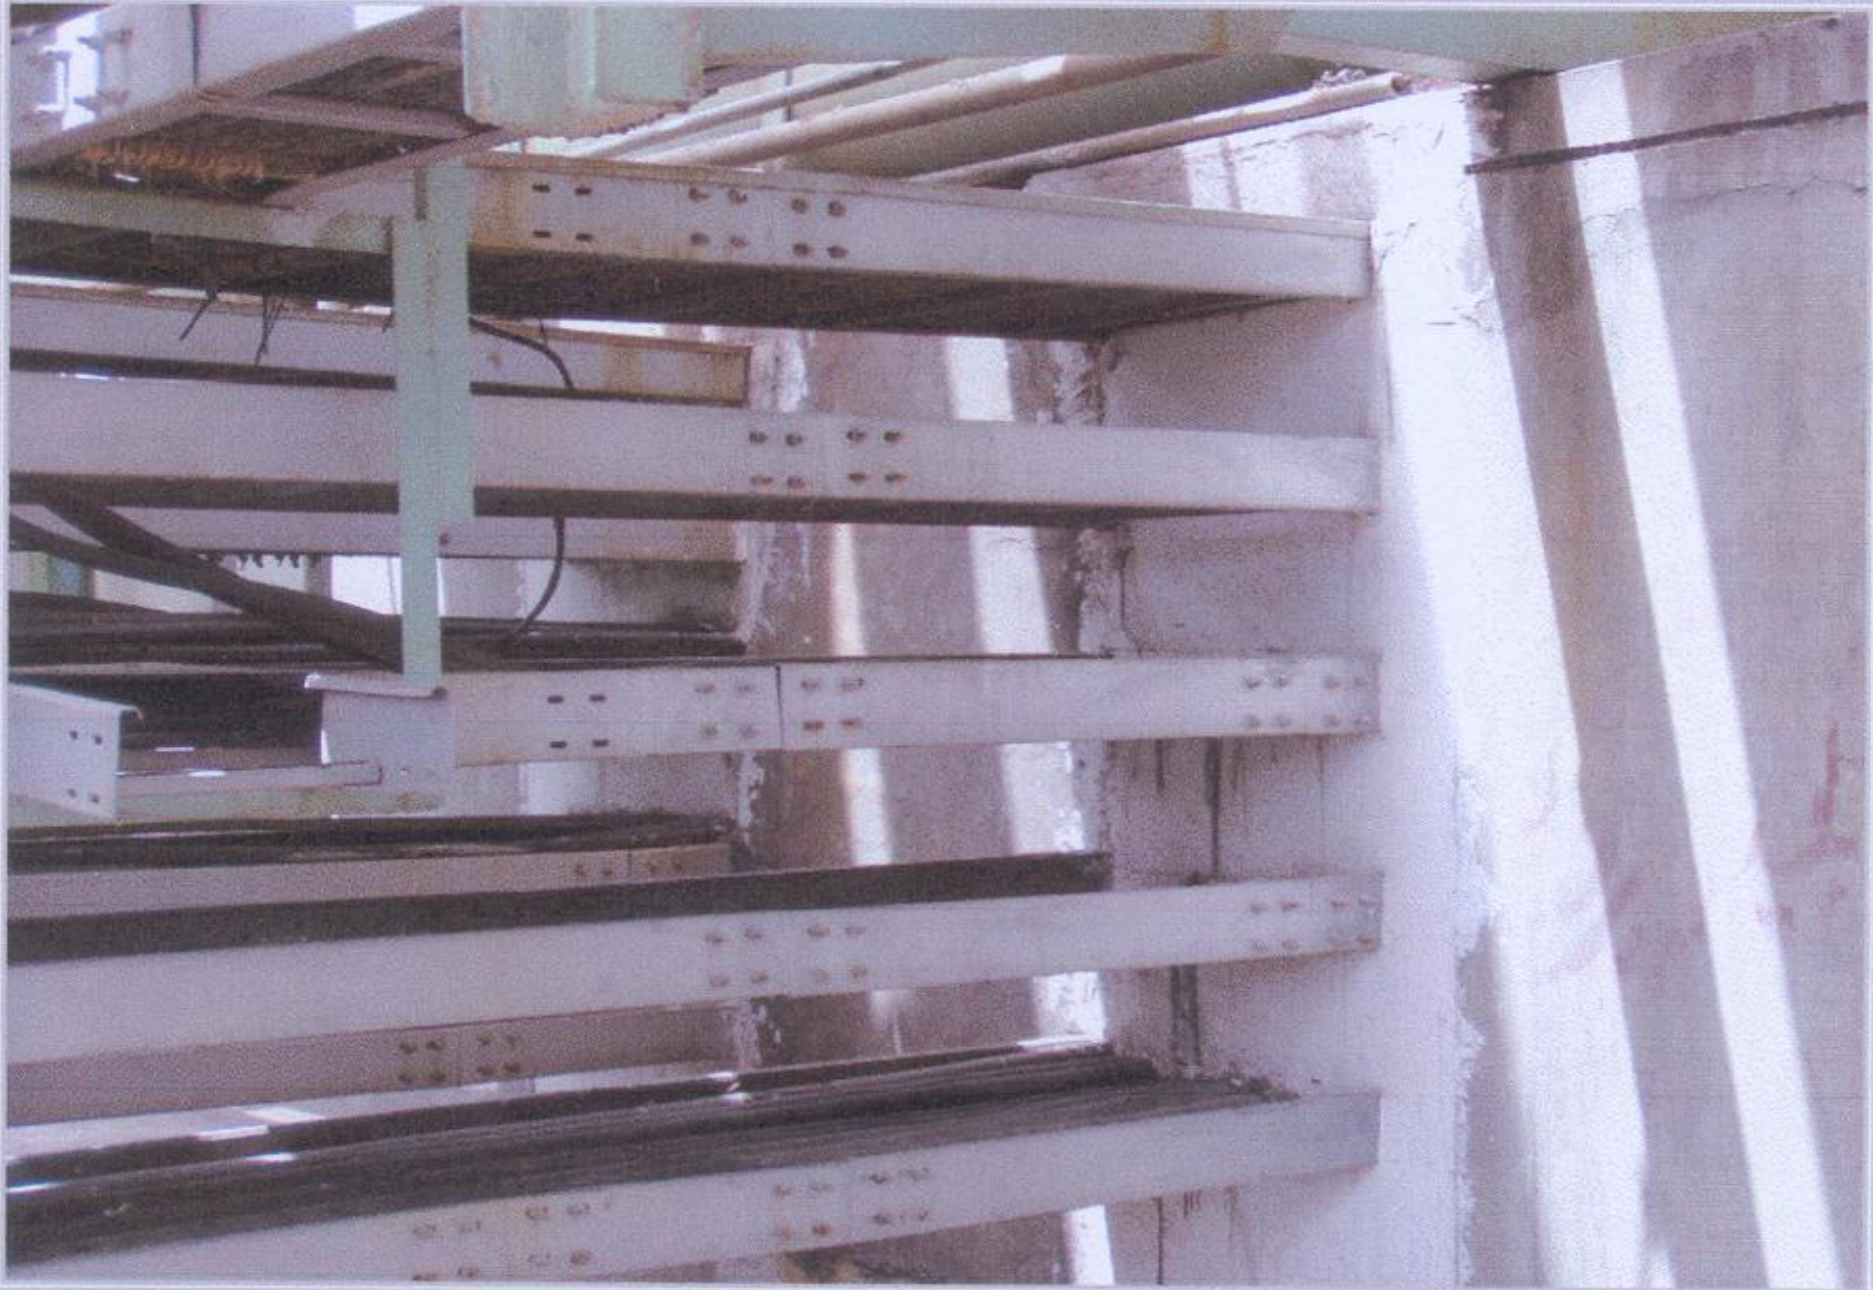
**Effective Fire-Stopping on Cable Tray Penetration through external wall of Engine room above Ground level**

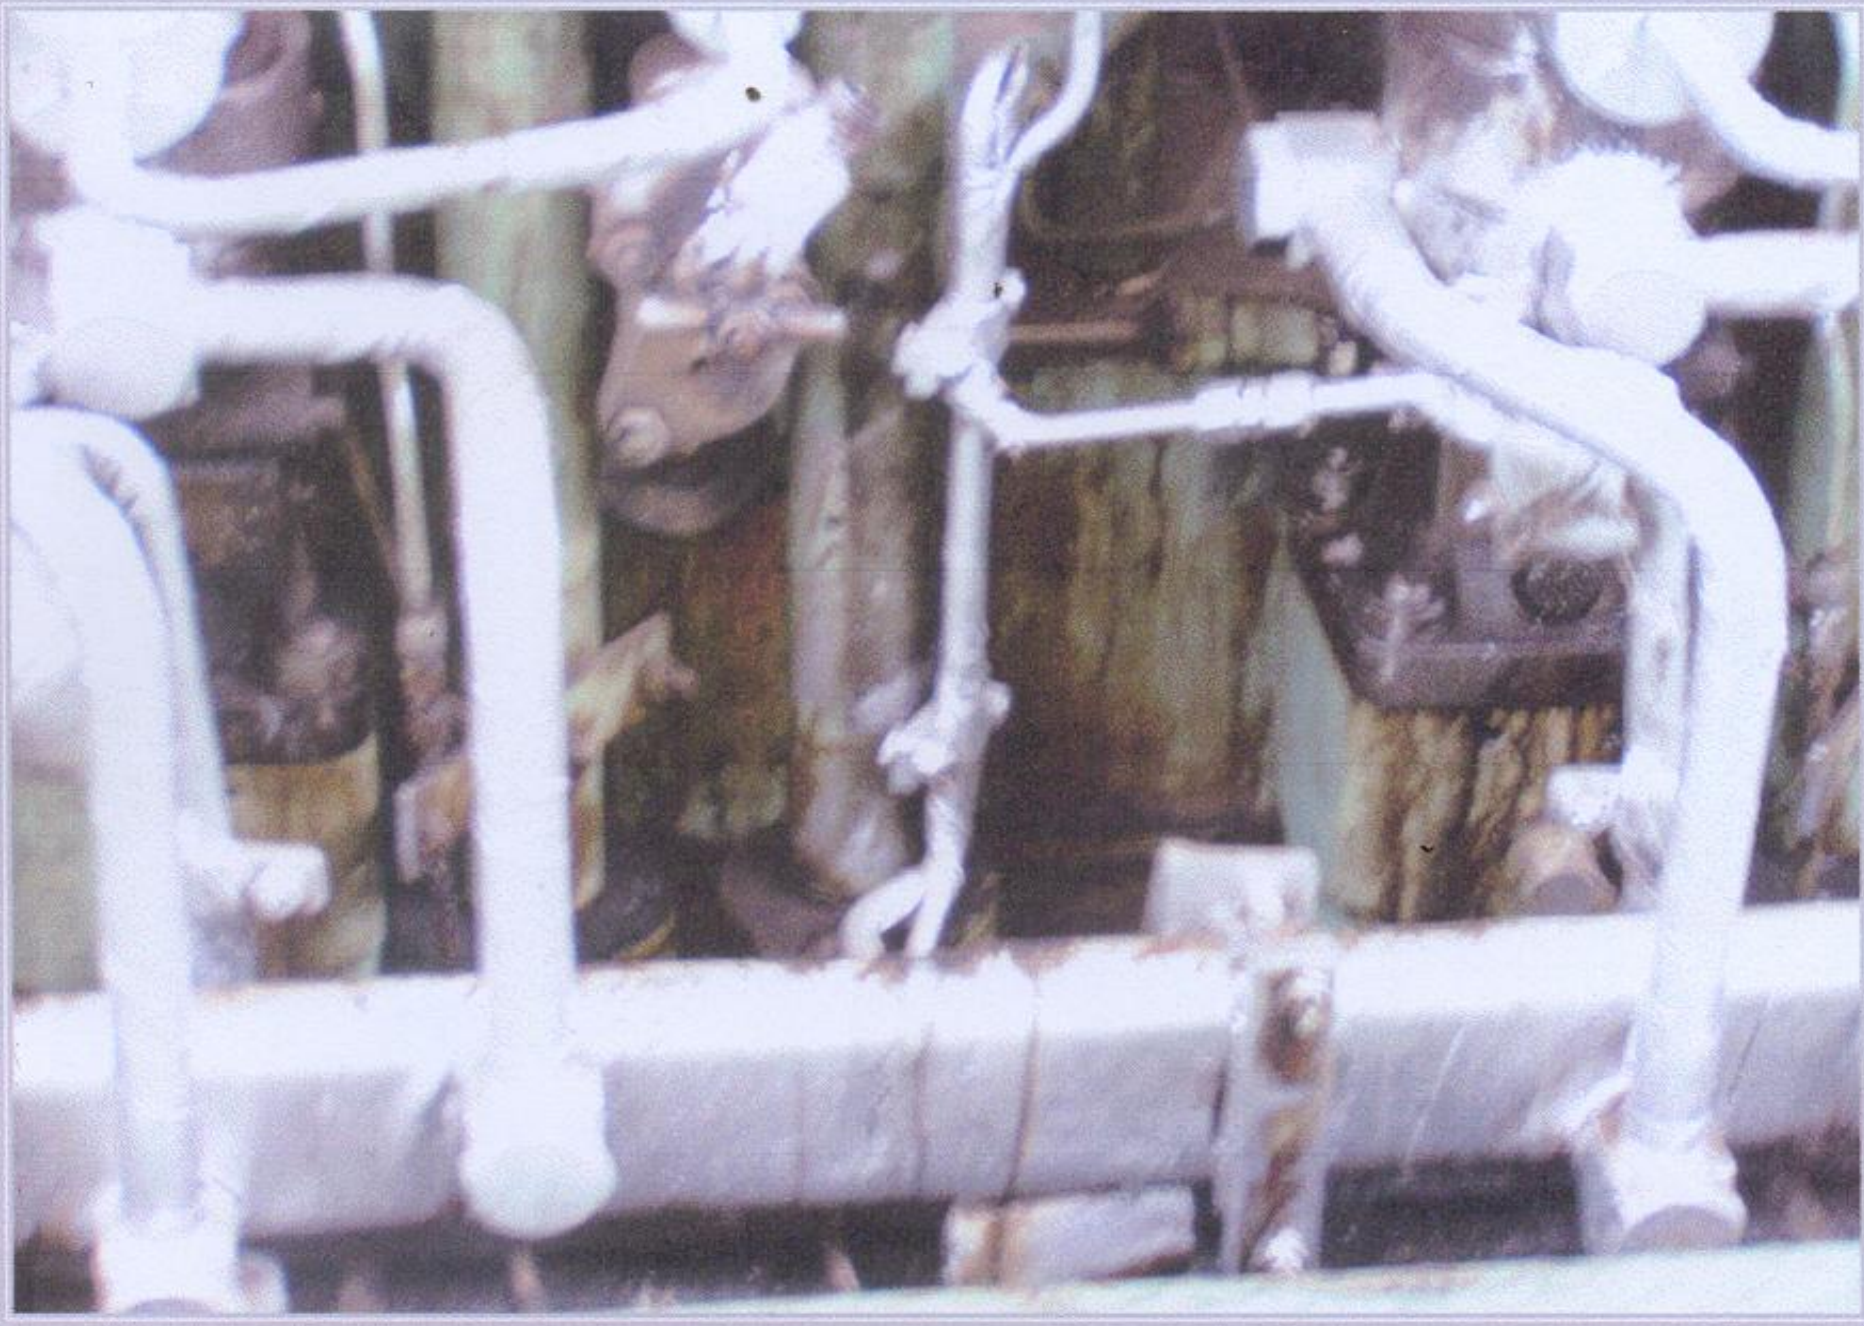
**General Poor Condition of Engine Crankcase**

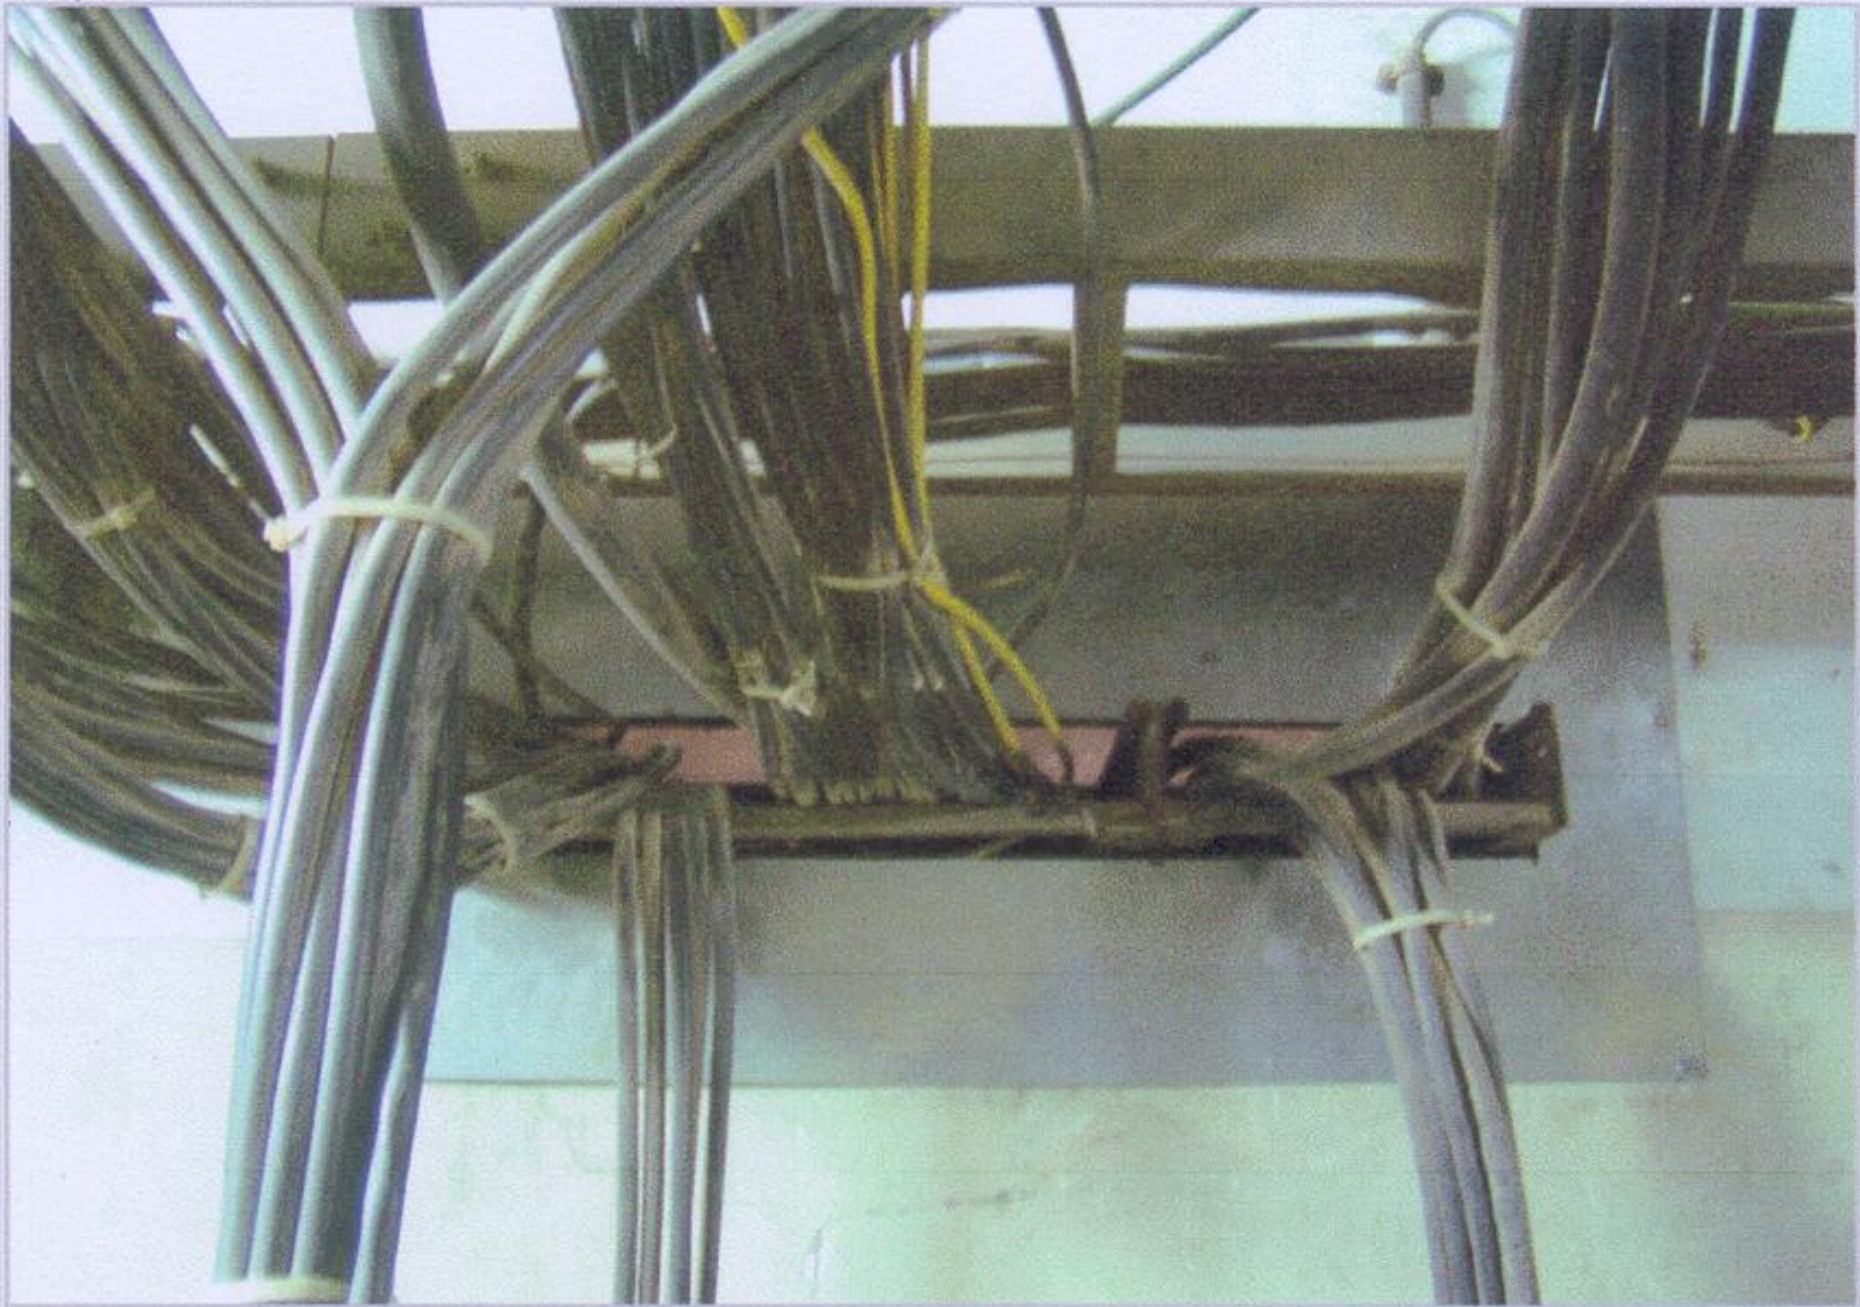
**Lack of Fire Stopping on Cable Runs in Engine Room Basement**

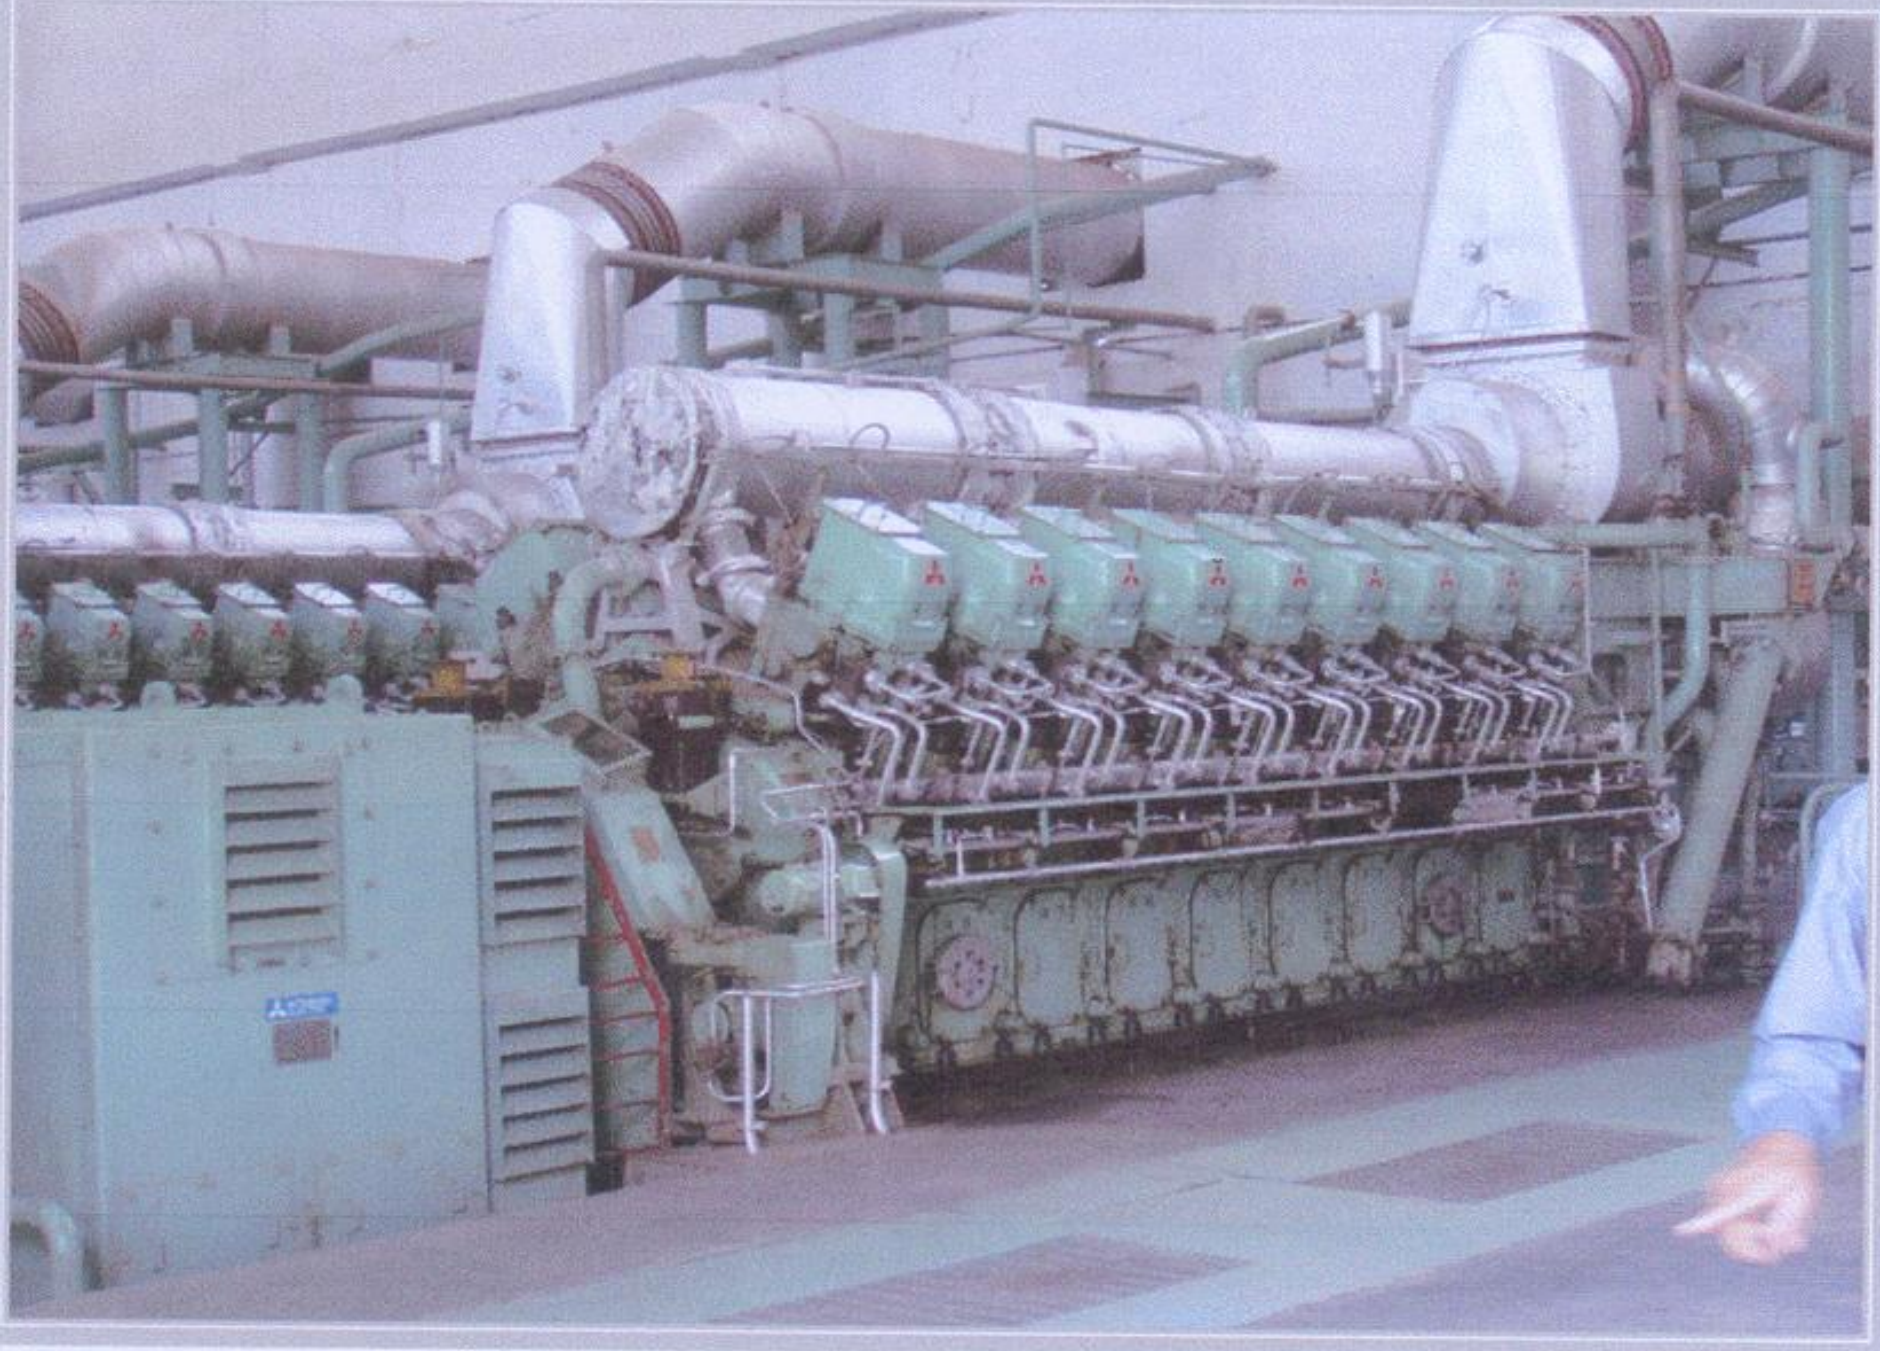
**Oil Staining Around Base of Engine**

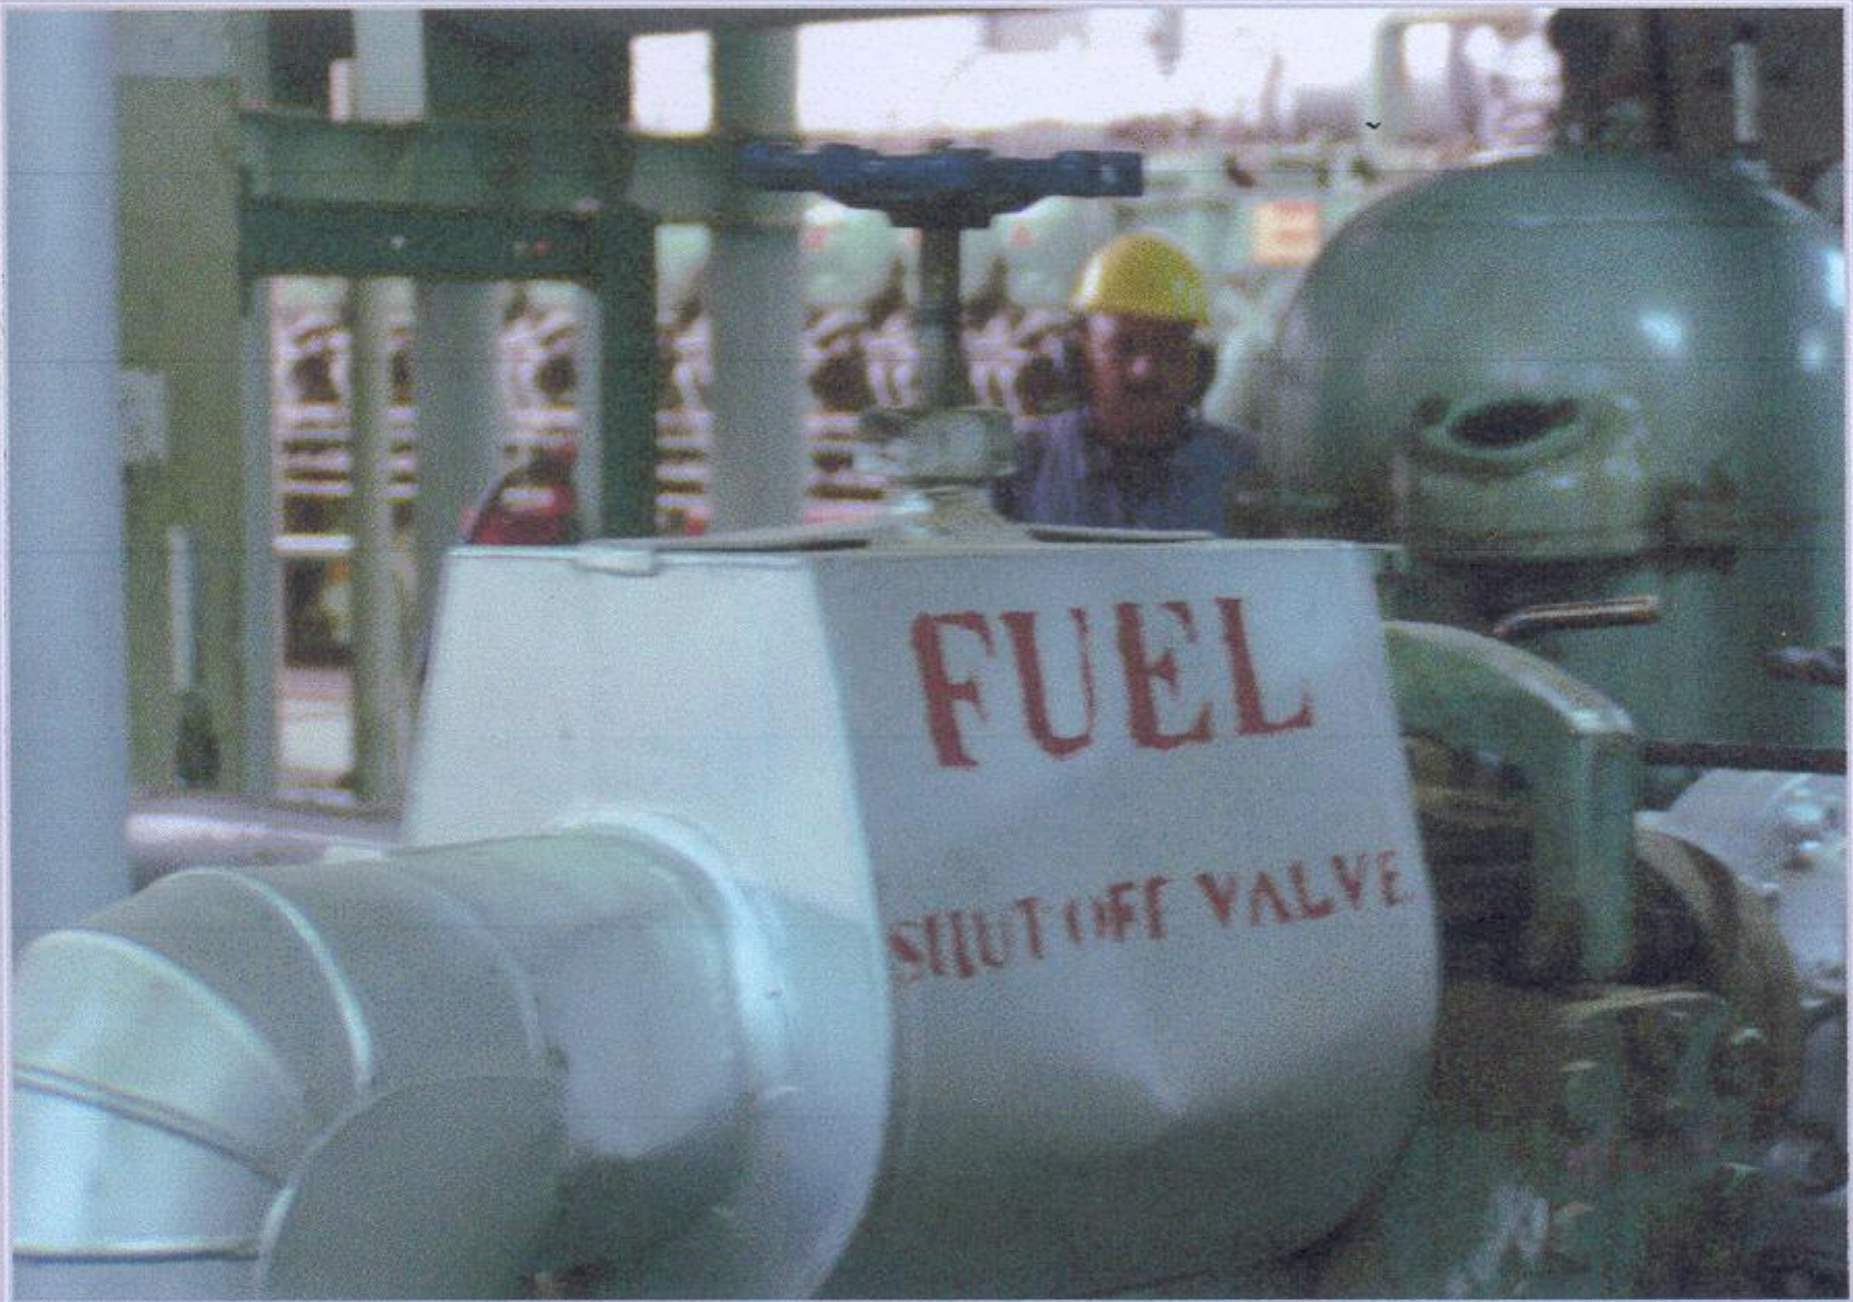
**All Fuel Shut-Off Valves now effectively Marked**

We recommend that this valve be clearly delineated by clear marking so that in the event of a significant fire event at an engine the operator can rapidly utilise the valve to close off the oil.

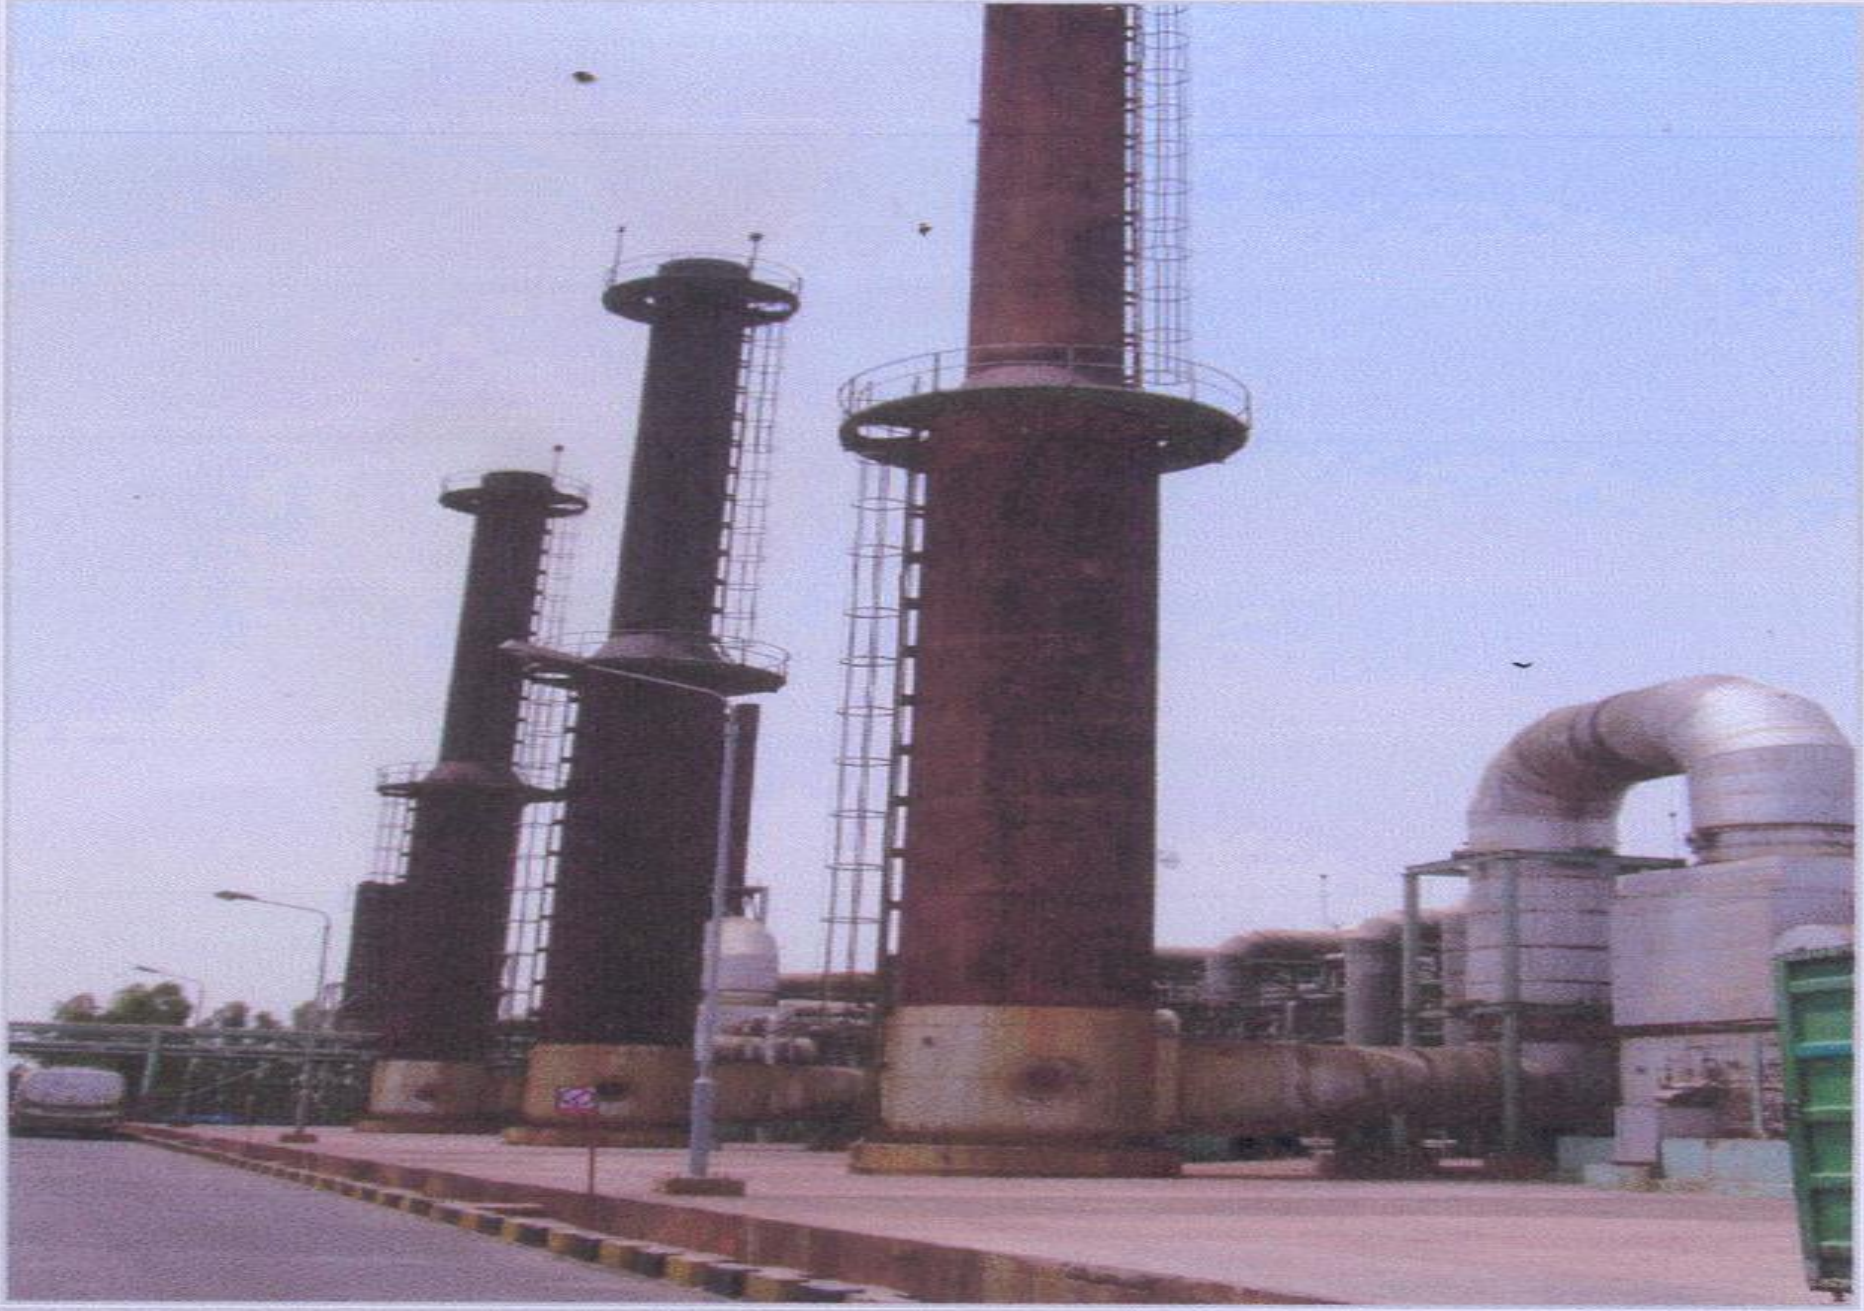
**Rust Staining on Exhaust Stacks**
