# EFU GENERAL INSURANCE

## SPECIFIC RISKS AND LOSS EXAMPLES FOR POWER PLANTS

Khurram Ali Khan

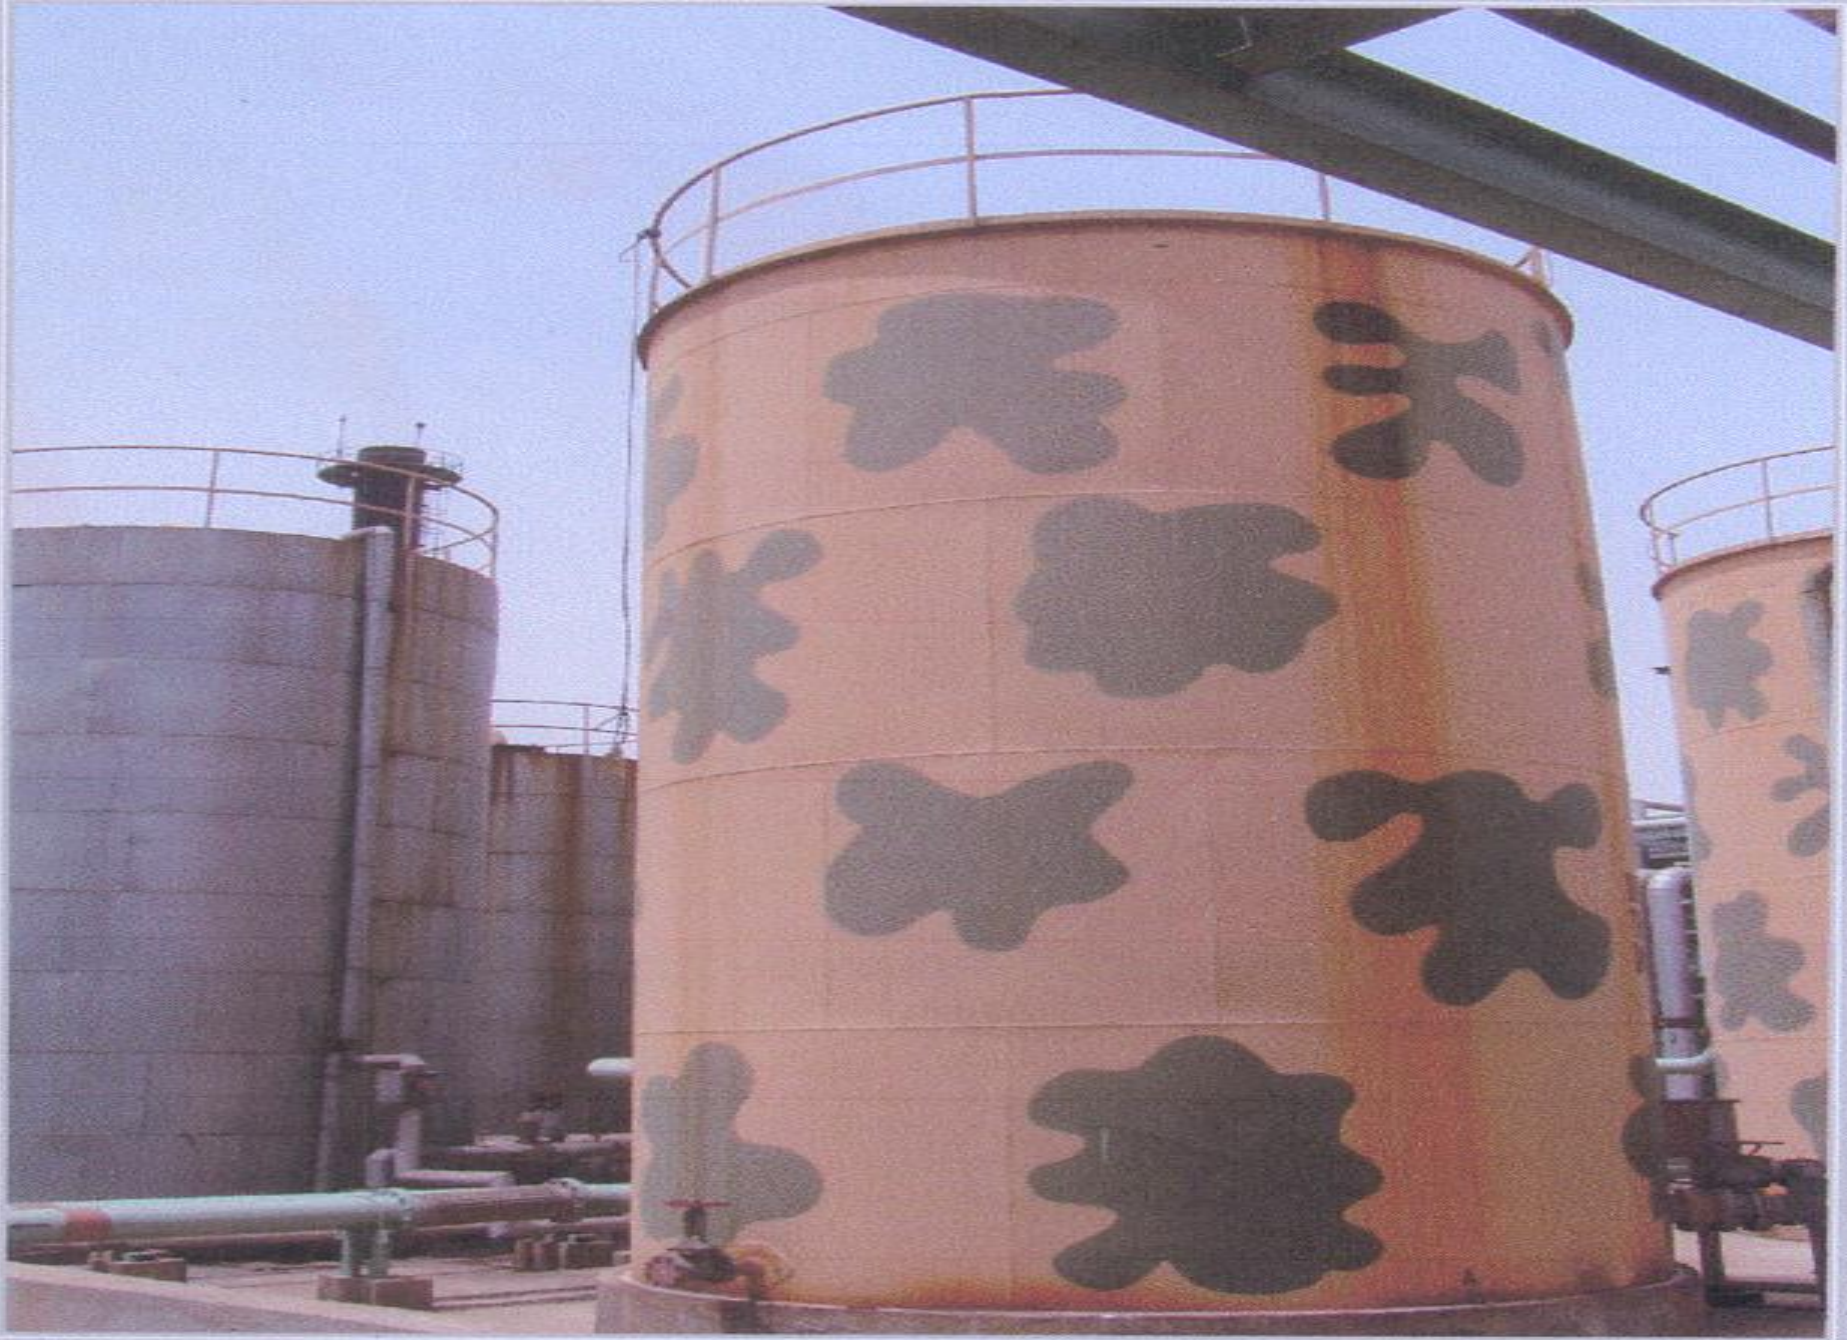
**Rust Staining on Storage Tanks**
